Subject: RE: Sediment Core Sampling - 8/14/18

We collected sediment core SC-S109 this morning at river mile 6.2. The core was collected on the first attempt with a total depth of 13.4 ft and total recovery length of 10.8 ft (80.5% recovery). Please see the pictures below for details.

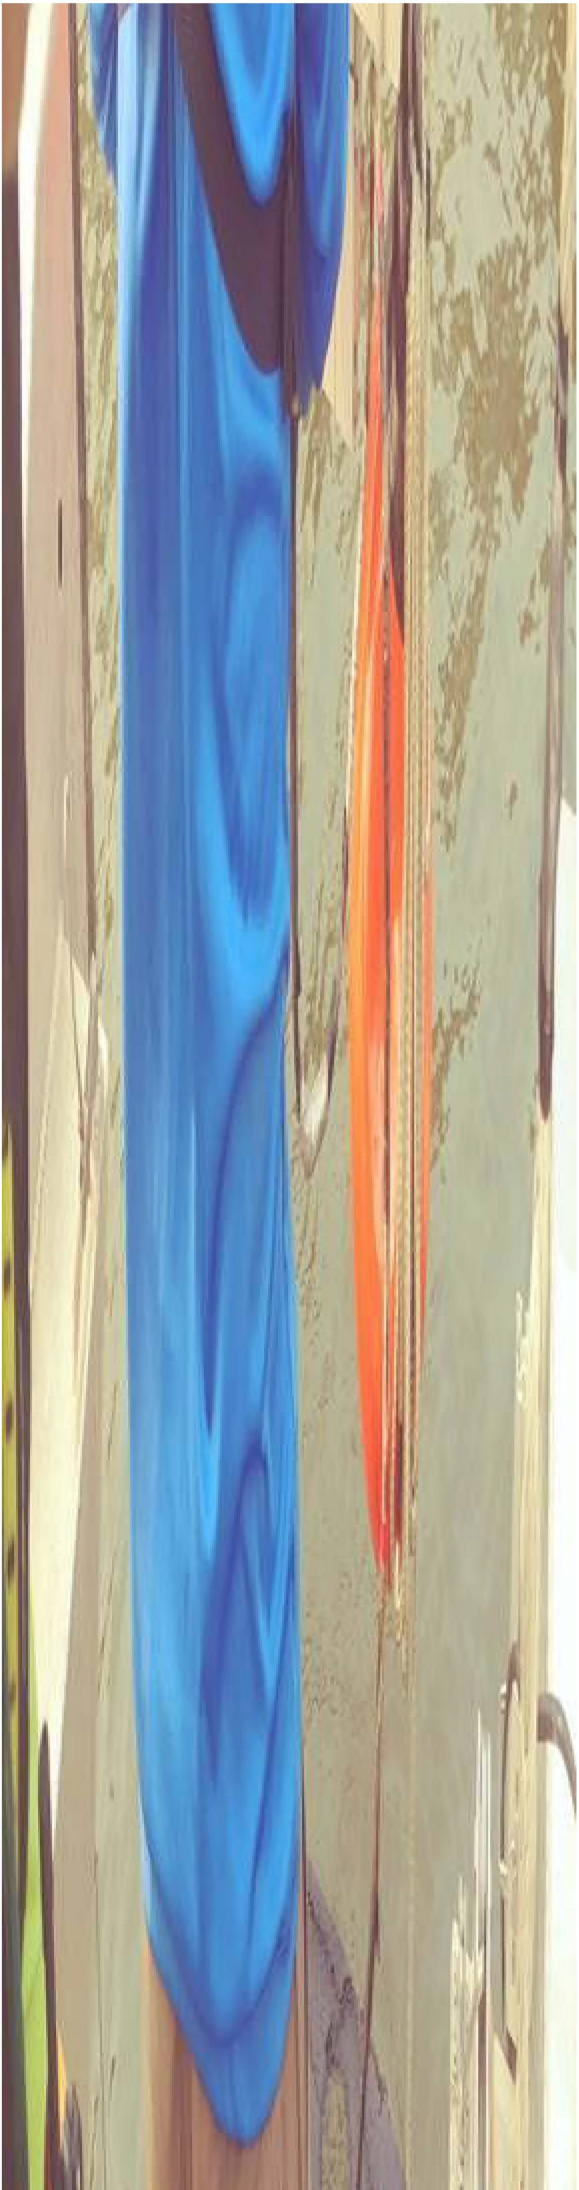
Photo 2: A small amount of NAPL was released from the bottom of the core barrel onto the deck. The deck was cleaned with an absorbent pad that was collected for containerization at storage building. This photo was taken immediately after the cleaning. No NAPL reached the harbor and no sheen was observed during coring.

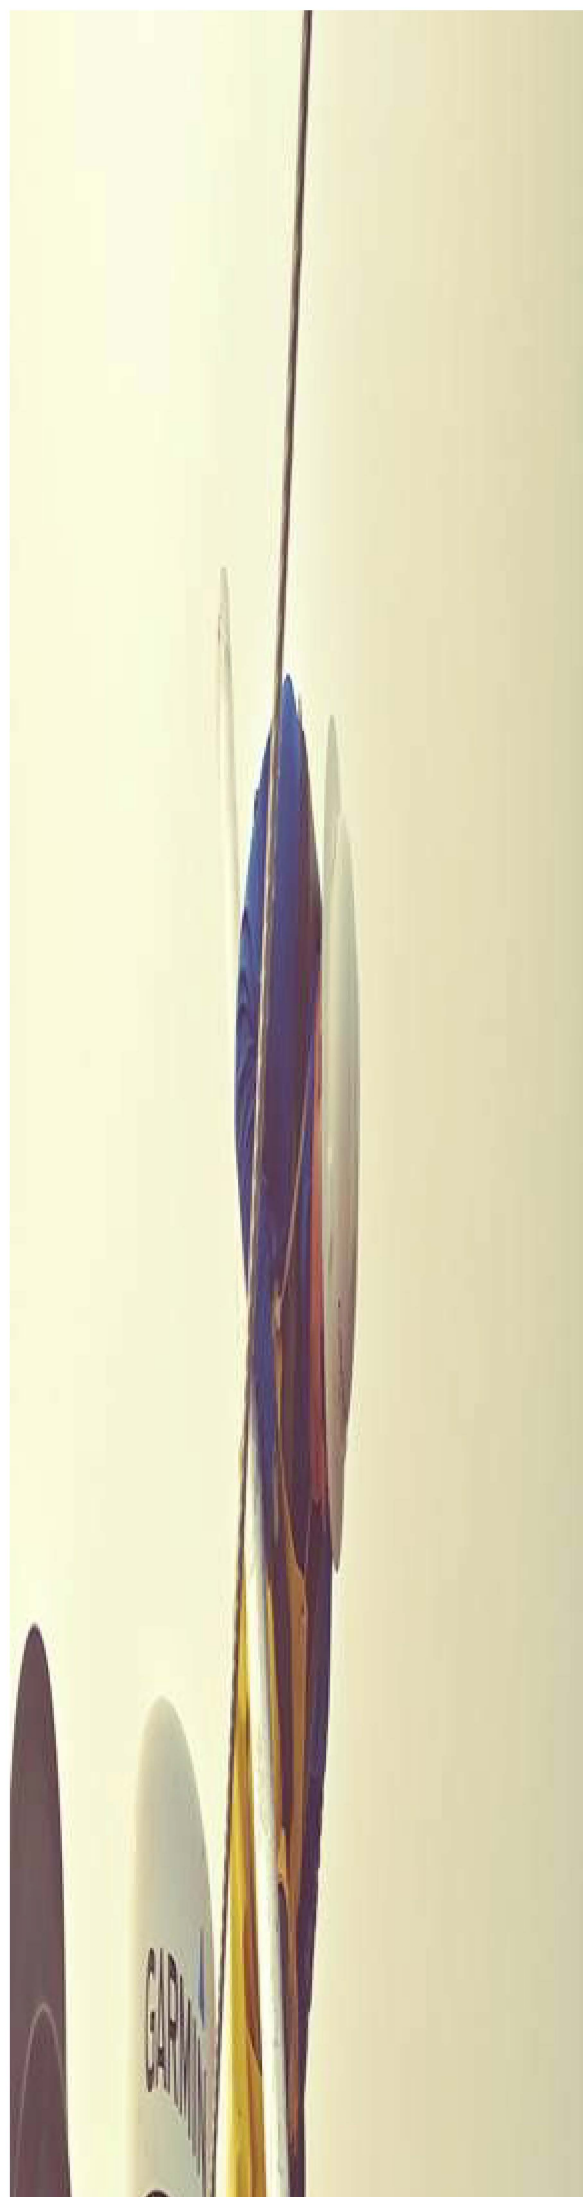
Photo 3: Draining water from the core barrel
